遠隔装填システムによる装薬作業の完全自動化への取組み

—国道45号 山田第2トンネル—

復興支援道路最長のトンネルを合理的な地山評価と施工法で掘削

—宮古盛岡横断道路 新区界トンネル—

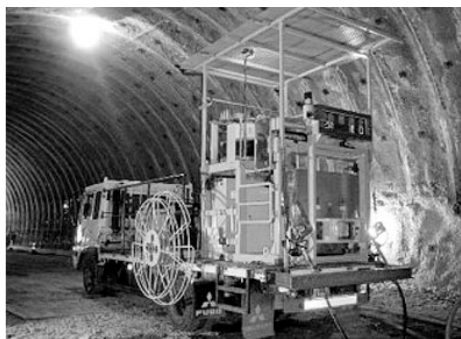
写真は爆薬の遠隔装填装置

安全性の向上のため、装薬作業をできるだけ切羽から離れて行うこと、作業姿勢の改善、装薬の機械化および全自動化を目的とした爆薬の遠隔装填システムを本トンネル工事に導入した。

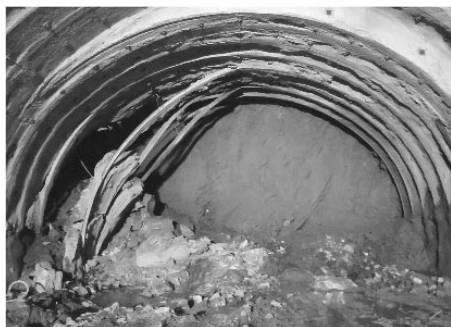
写真は支保変状状況(葉片状蛇紋岩)

新区界トンネルは、岩手県宮古市と盛岡市の市境に位置する全長4,998mの長大トンネルである。本トンネルの地質は、連続性に乏しく、かつ、きわめて複雑な地層を形成する付加体である。粘板岩と蛇紋岩からなる破碎帯区間では、大規模な支保崩壊や天端部の崩落が発生し、施工が著しく難渋した。そこで日々の切羽観察に加えコンピュータジャンボで得られる穿孔エネルギーデータを利用した地山評価を行い、合理的な支保パターンの選定(高耐力支保、早期閉合、補助工法の要否など)を行った。また、A・B計測データをもとにした数値解析などを通じて支保パターンの妥当性を検証した事例について報告する。

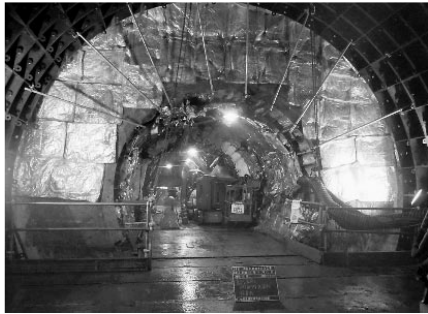
写真は凍土面防熱材設置状況

隅田川幹線は、千住地区における雨水排除能力の向上とポンプ施設の再構築を目的とし、既設の2か所のポンプ所の雨水を新設するポンプ所に送水するために布設するもので、外径5,500mm、延長3.11kmのシールドトンネルを泥水式シールド工法で施工したものである。この幹線の発進立坑から約1.2km地点において、幹線の発進側と到達側にあるポンプ所からの雨水を新設ポンプ所に流入させる外径6,350mmのシールドトンネルを連結する必要があり、当該箇所において凍結工法を用いてシールドトンネルの拡幅を行った。本稿は、この拡幅工事の概要と拡幅の補助工法である凍結工事について報告するものである。
